VEHICLE ACCIDENT INVESTIGATION

CASE NO. 90-10

TECHNICAL REPORT

NHTSA IN-DEPTH AIRBAG ACCIDENT INVESTIGATION CASE: 90-10

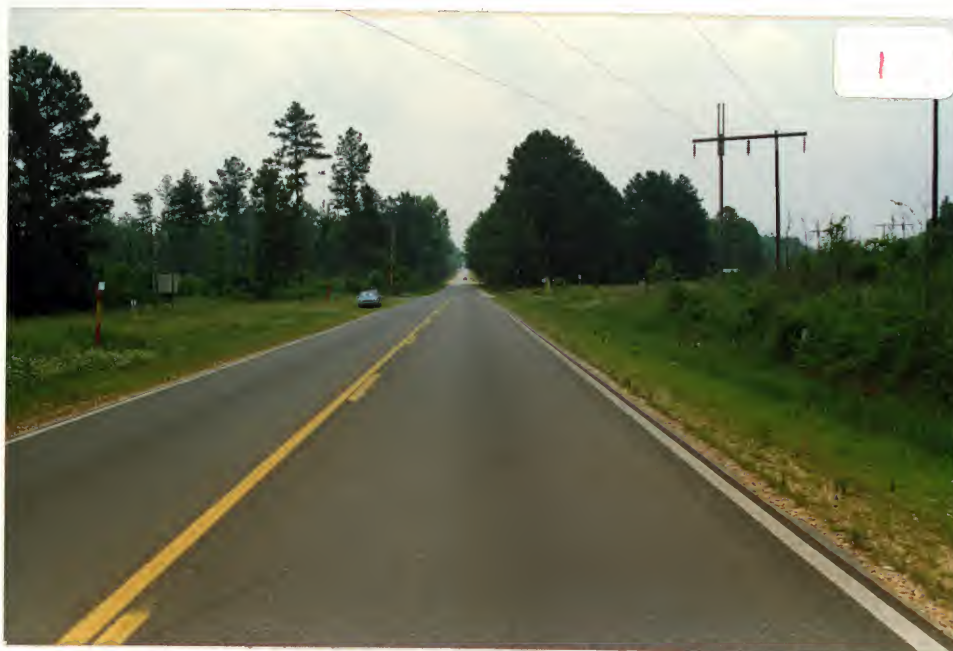
1. Pre-impact direction of travel of both vehicles, south on State

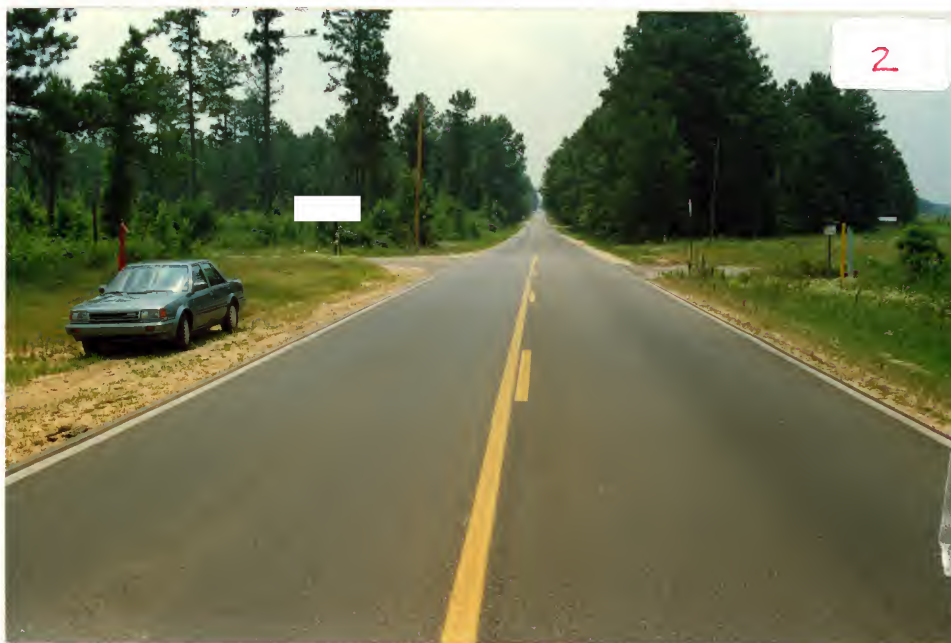
2. Area where the airbag vehicle begins to pass vehicle #2.

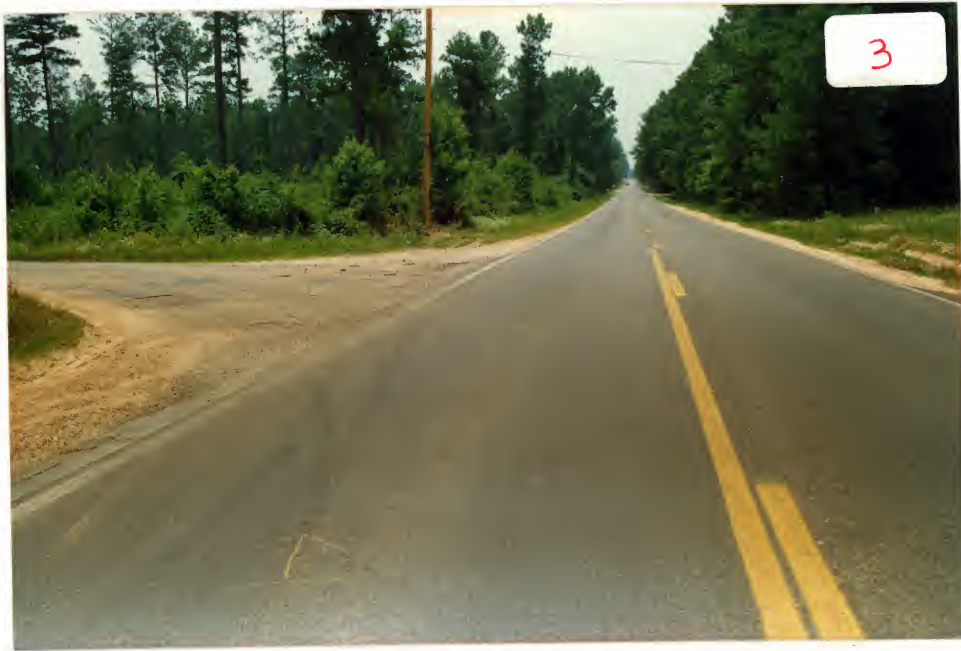
3. Area of impact between the airbag vehicle and vehicle #2.

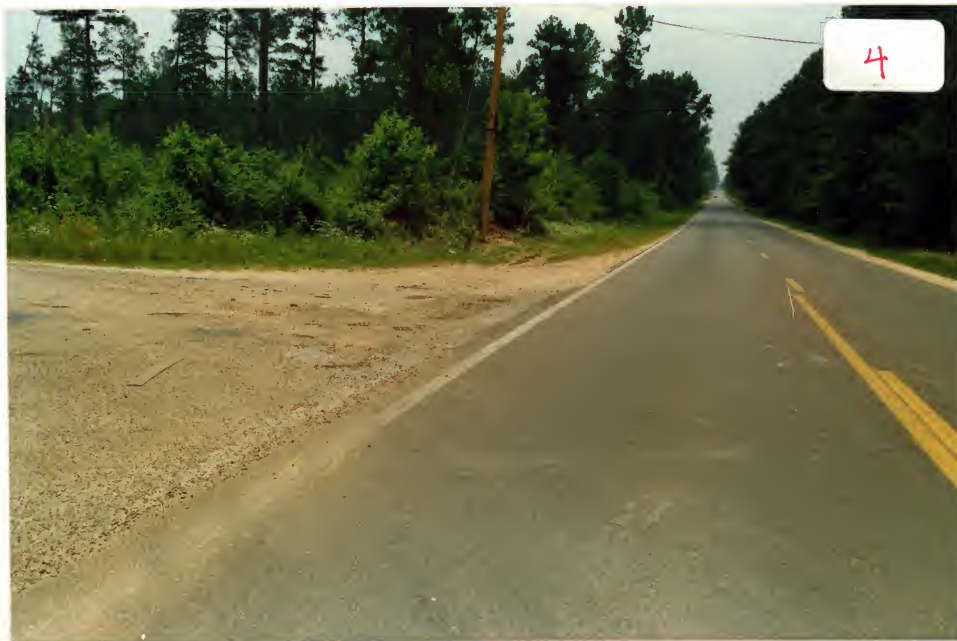
4. Path of the airbag vehicle following impact with vehicle #2.

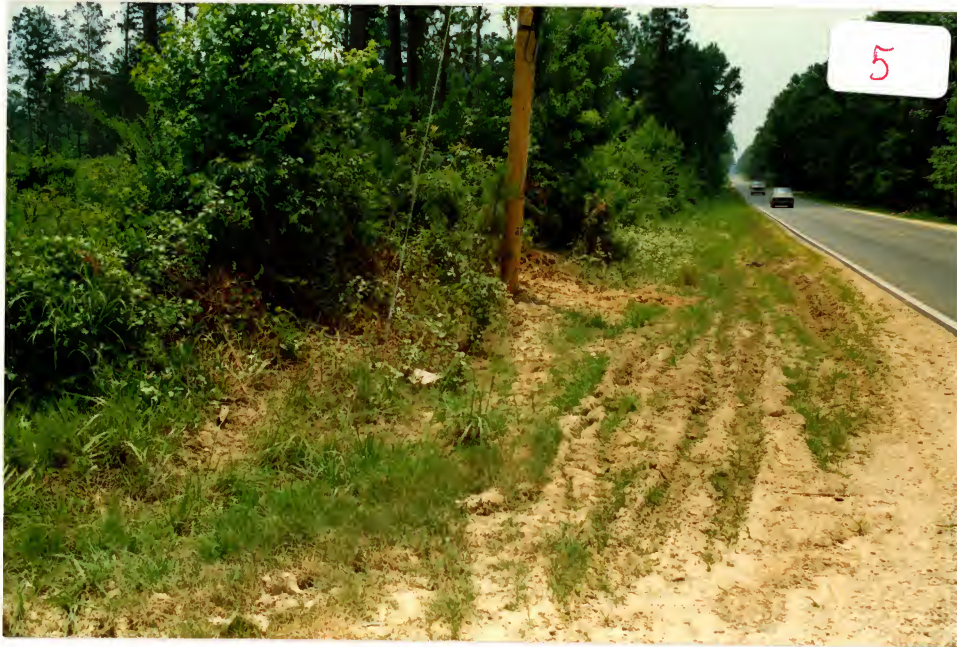
5. Path of the airbag vehicle to impact with the guy wire and wooden utility pole. .

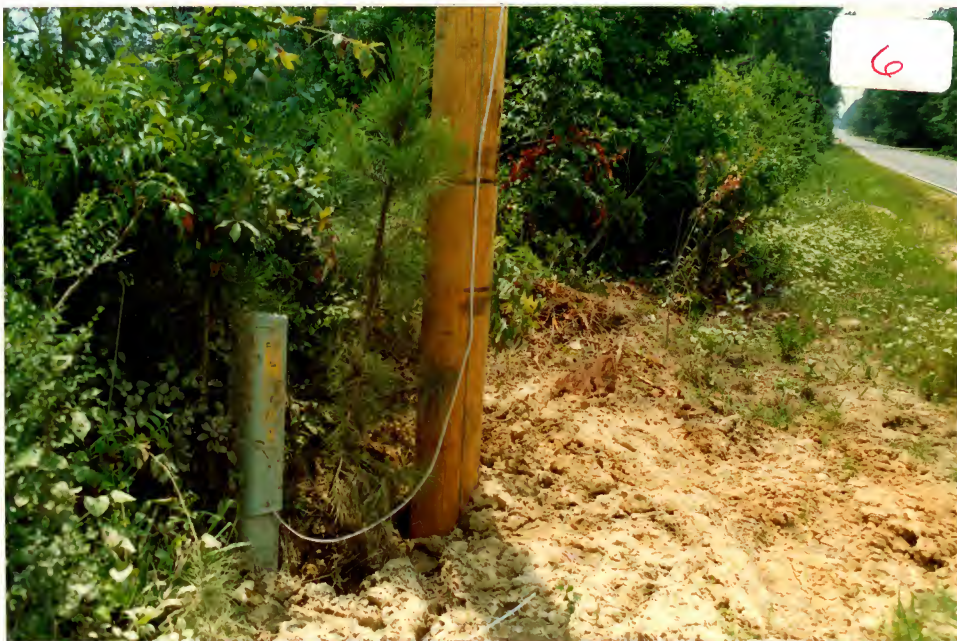
6. View of the impact area with the utility pole and final rest area of the airbag vehicle. Note the pole has been replaced.

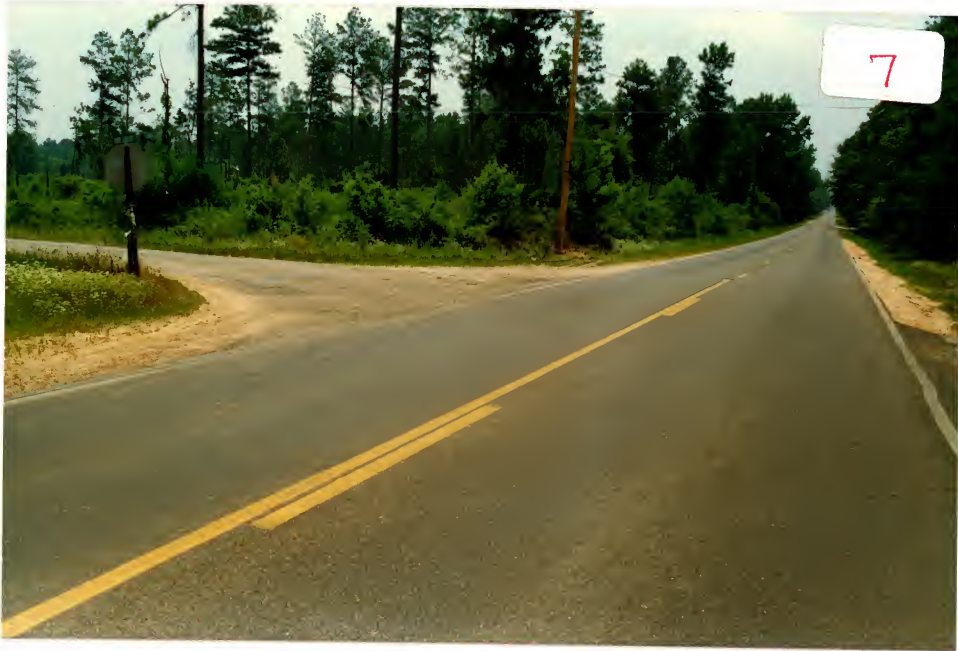
7. View of the area where vehicle #2 attempts a left turn onto Road.

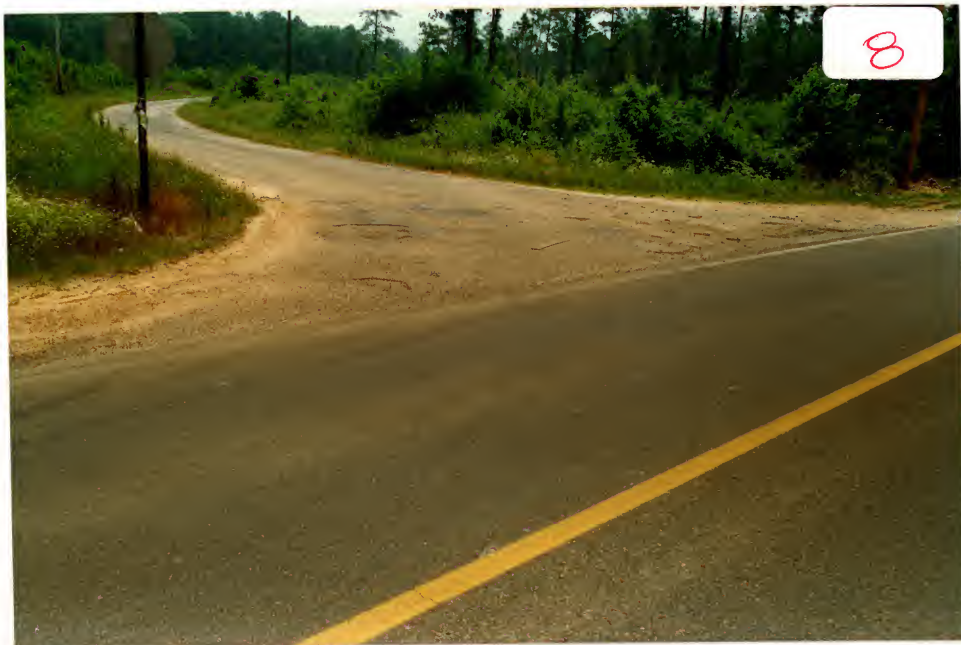
8. Area of impact between vehicle #2 and the airbag vehicle.

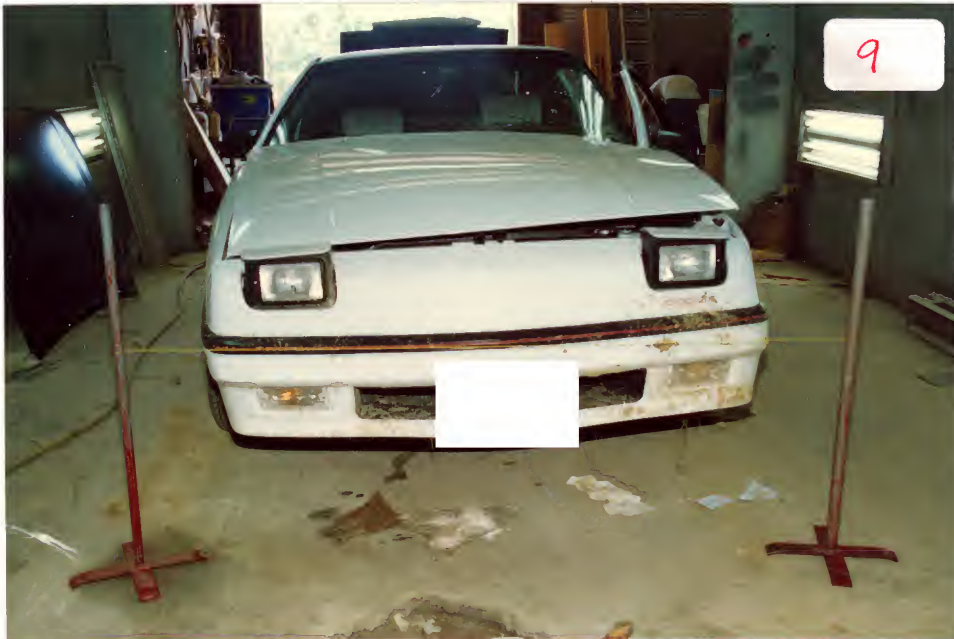
9. Frontal view of the airbag vehicle.

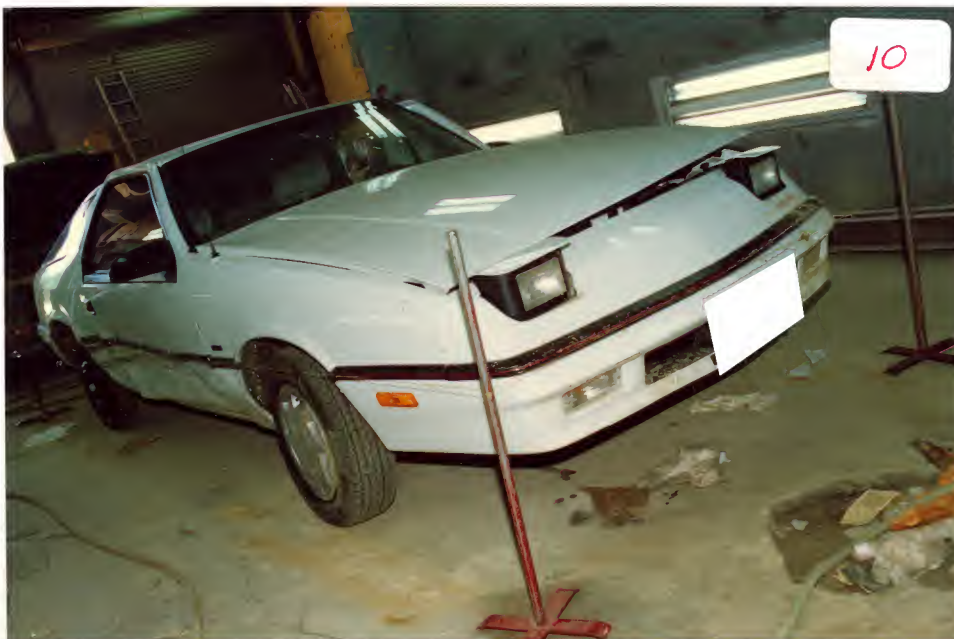
Exterior:	<p>The right side of the airbag vehicle was struck by vehicle #2. Direct contact damage extended 90 inches along the right side from just behind the right front wheel to the right rear wheel. The most significant crush was along the lower surface of the door. A CDC of 01-RZEW-2 was assigned to this impact damage. Crush dimensions measured at the lower right side surface were:</p>

10. Right front three-quarter view of the vehicle showing damage from the impact with vehicle #2.

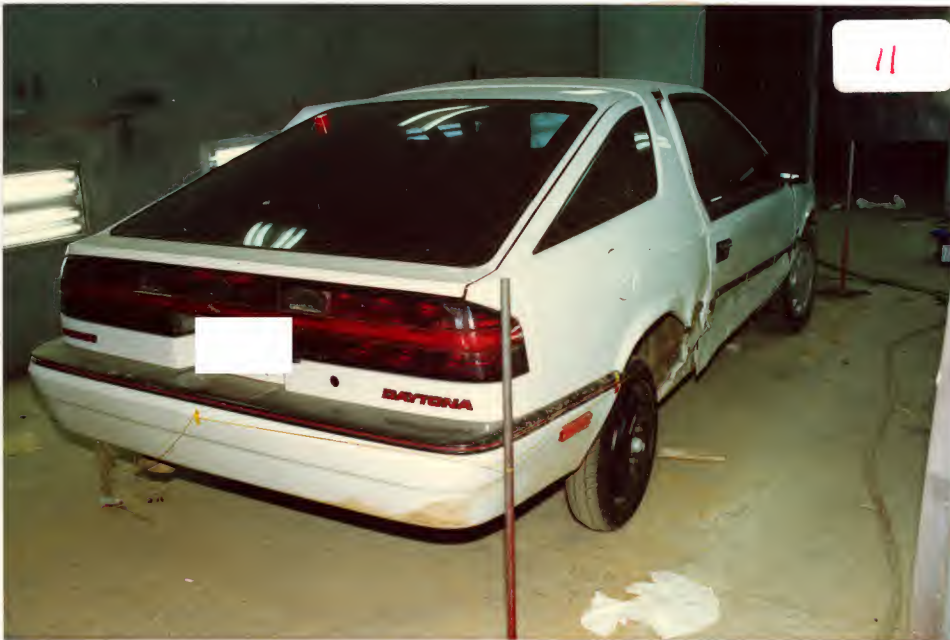
11. Right rear three-quarter view showing damage to the right side.

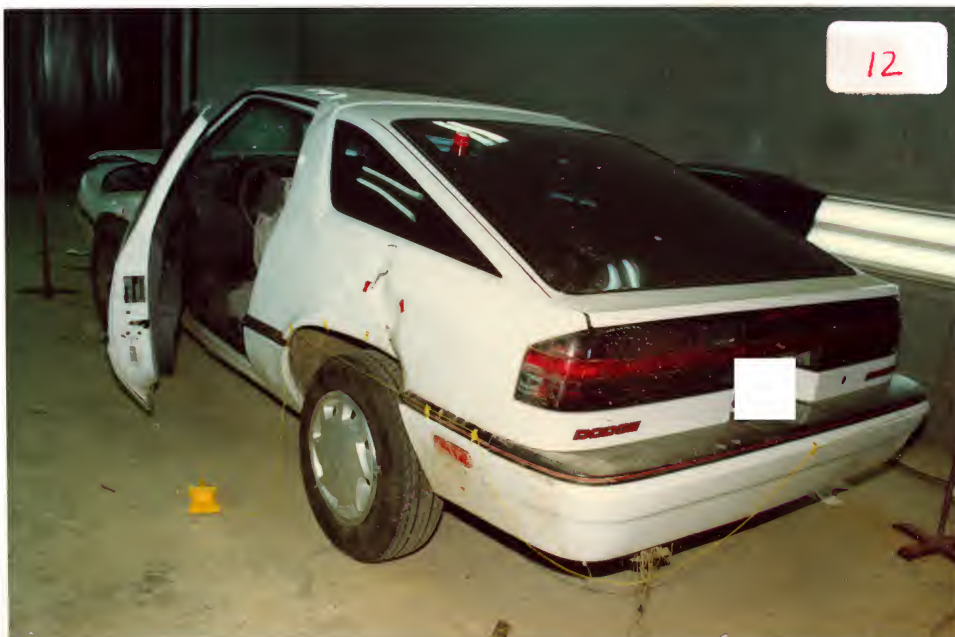
Following the impact with vehicle #2, the airbag vehicle rotated clockwise and departed the roadway with the left side leading. The left rear quarter-panel struck a guy wire resulting in direct damage that extended 6 inches along the left side surface. Direct plus induced damage extended 33 inches along the left rear quarter-panel. A CDC of 10-LBEN-01 was assigned

12. Left rear three-quarter view of the vehicle showing damage from the guy wire impact.

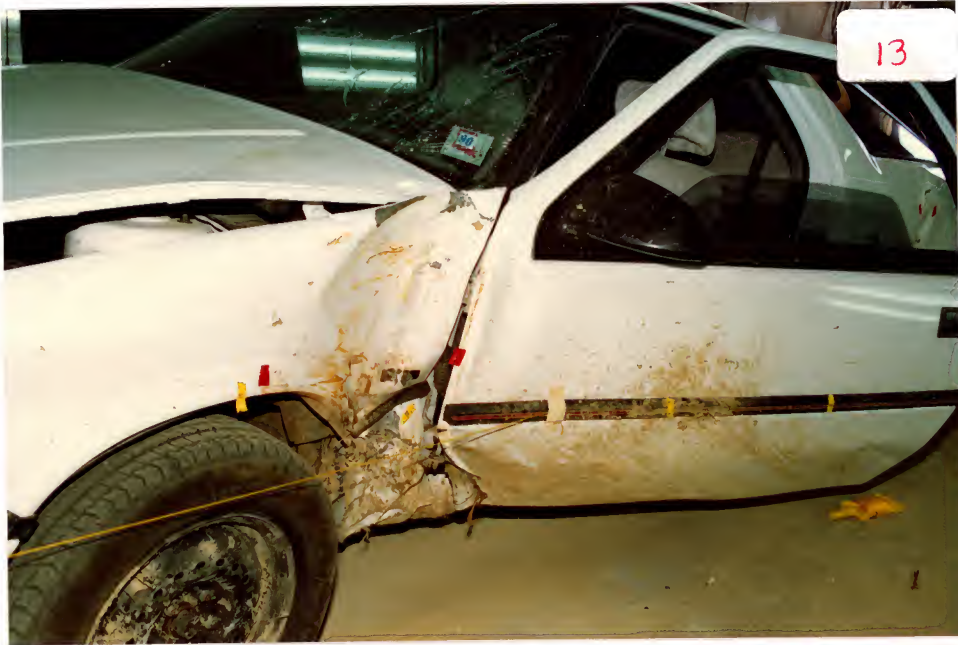
Direct impact damage from
the pole measured 16.0
inches from the rear of
the left front wheel to
the left front A-pillar.
Direct plus induced
damage extended 96 inches
along the left side from
the left front corner to
the middle of the left
door. A CDC of 11-LYAW-02
was assigned to this
impact damage. Crush
dimensions measured along
the left side were:

13. Left side view of the damage sustained in the impact with the pole.

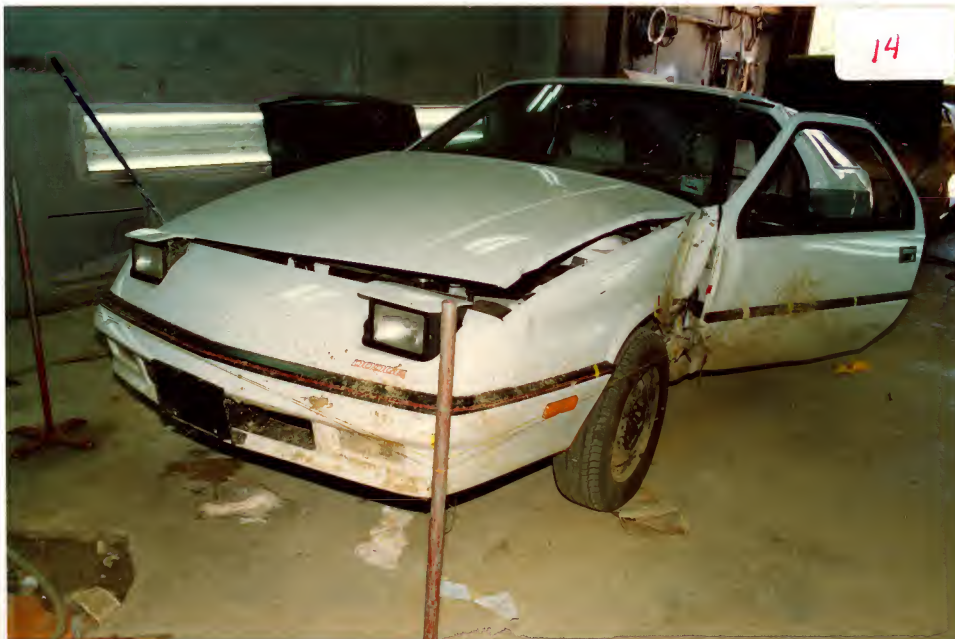
14. Left front three-quarter view of the Daytona.

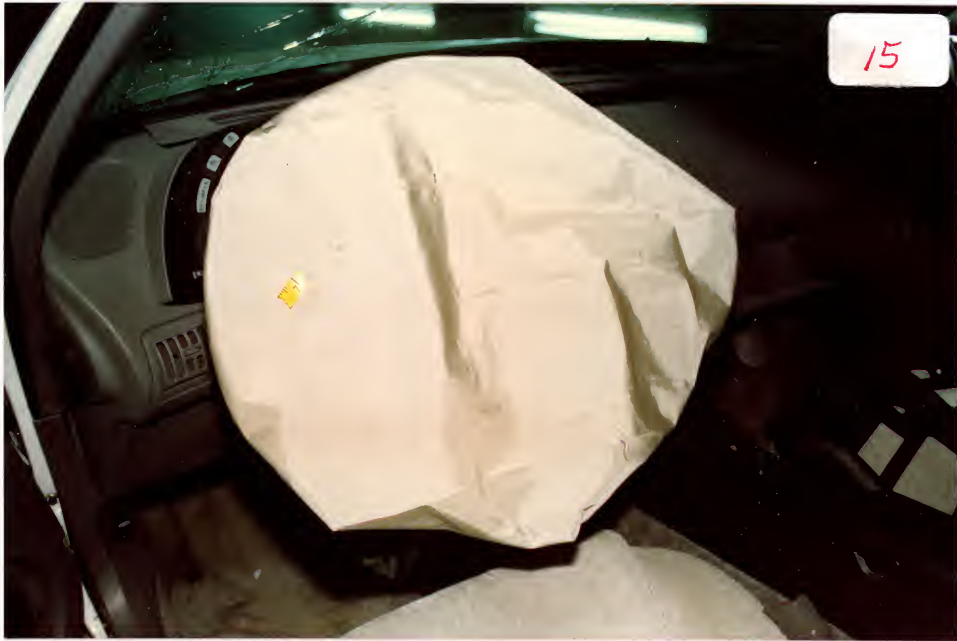
15. Interior view showing the deployed airbag.

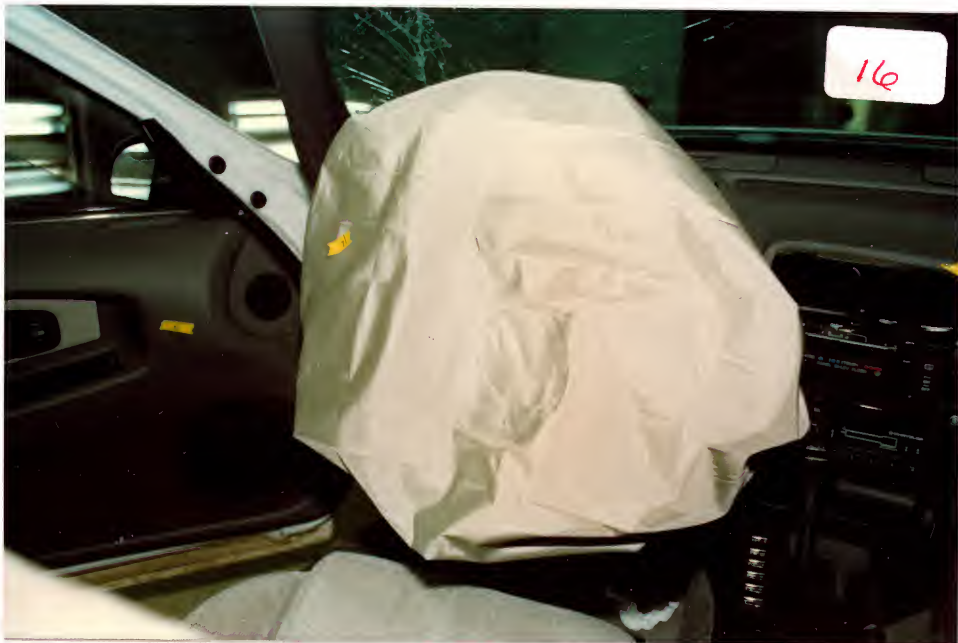
16. Interior view showing possible occupant contact to the airbag and driver's door.

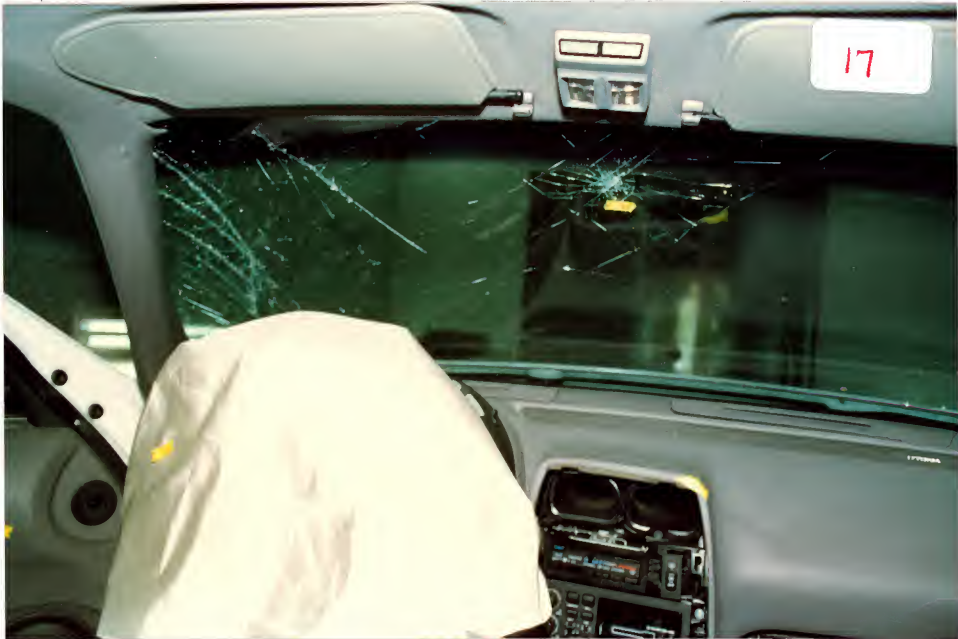
17. Interior view showing occupant contact to the rearview mirror, windshield and dash.

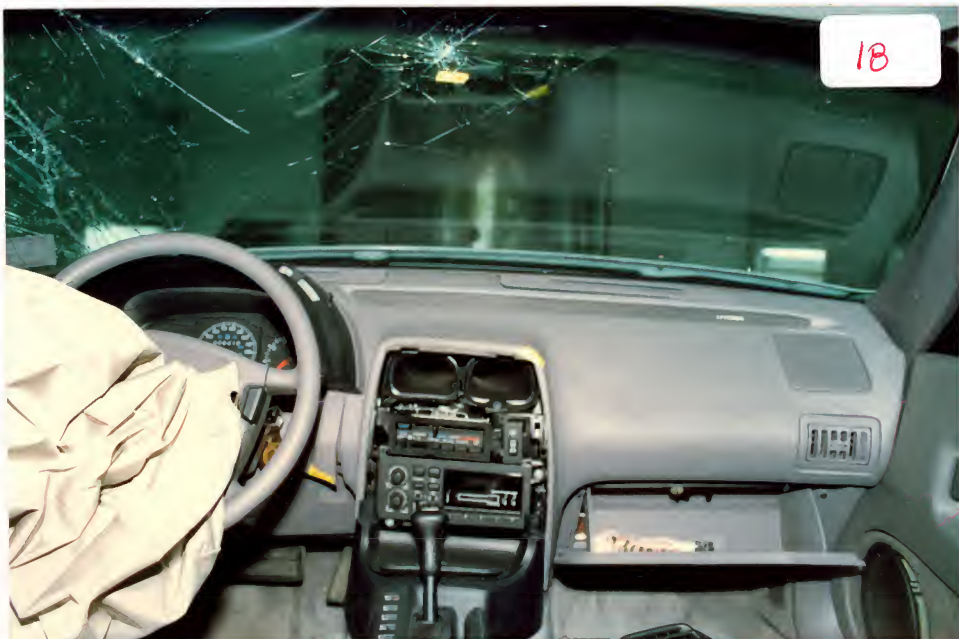
18. Interior view showing areas of possible occupant contact.

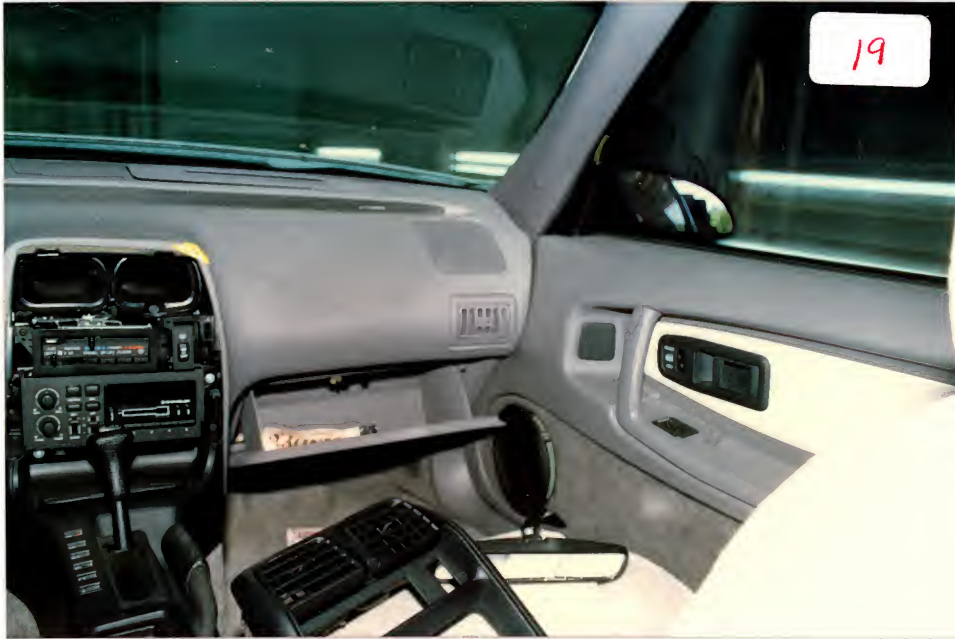
19. View of the right front passenger's area showing possible occupant contact and damaged interior components.
